Case Study

Corrizon Base – using outstanding anti-corrosive waterborne coat as part of paint system for maintenance.

**Warehouse
Construction**

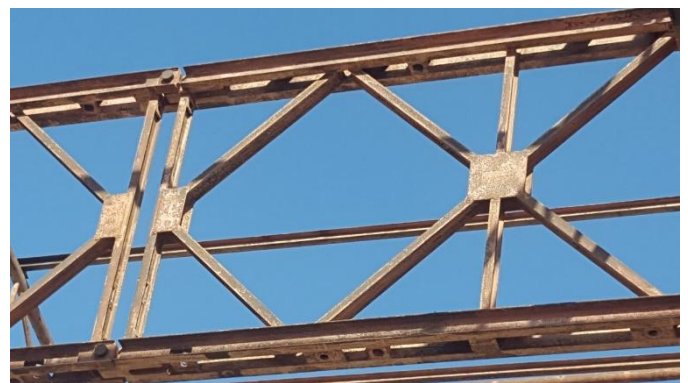
Warehouse's complexity element

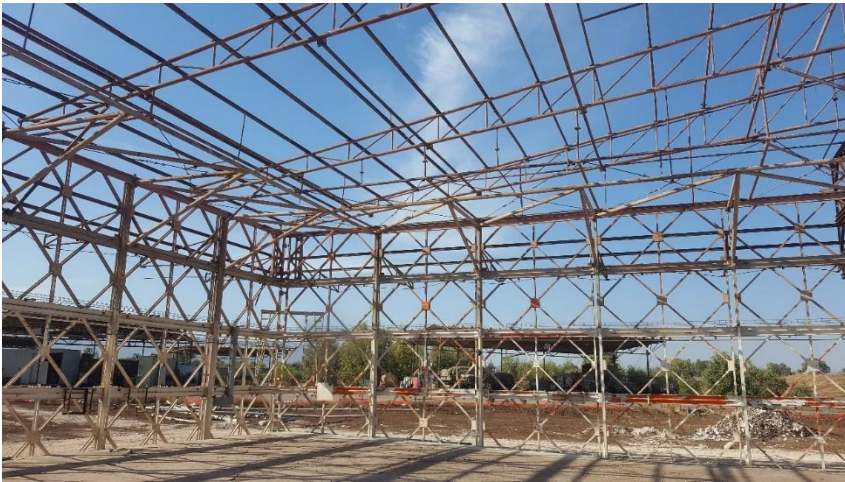
shed condition before treatment

The surface preparation was done by high pressure water cleaning (100-200 bars) to remove all loose paint, mill scale and rust. Once the surface dried, the maintenance crew used **Corrizon base** coat over the stable rust and old paint. The product has lower VOC (Volatile Organic Compound) ~0 enabling the crew to work free of any special protective equipment against fire. In the end, the product was returned to its original package for additional future uses. Twenty four hours later, they covered the **Corrizon base** layer with their common top paints on site.

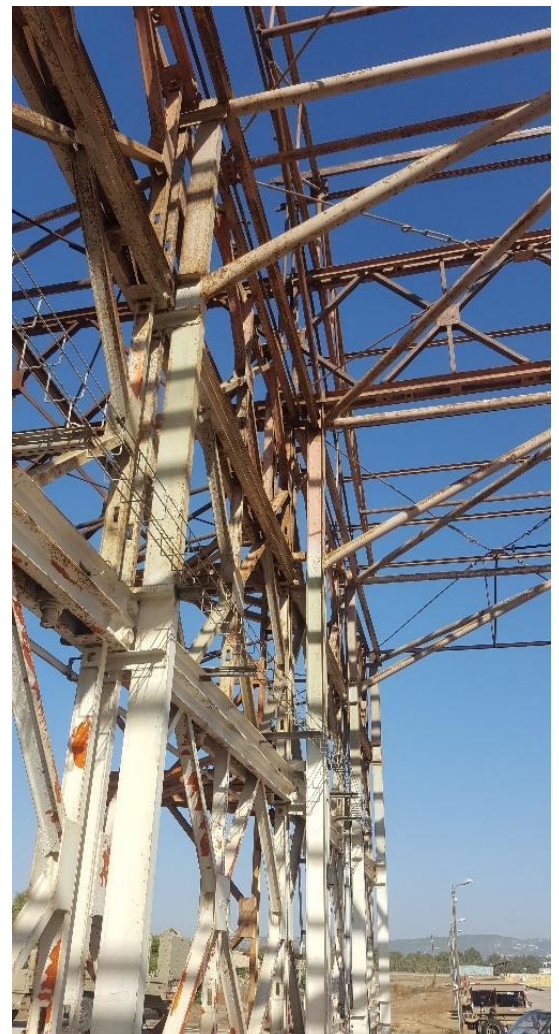
shed condition before treatment

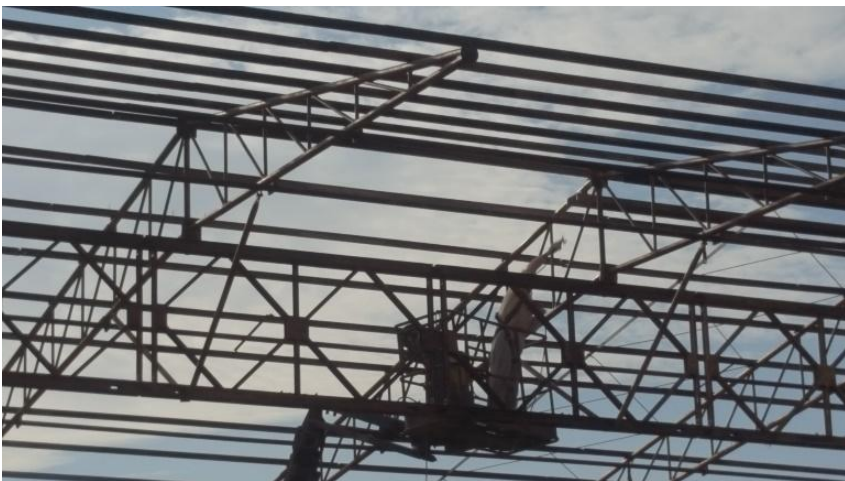
Single layer application with Airless

Once the surface had dried, treatment with the Corrizon Base began. When the material dries, it becomes transparent, so we add red pigment to the surface material to ensure full application where the paint remains white. Once the base coat finished, the shed was painted with a top coat according to the customer's request. More than a year and a half later, the shed remains in good shape.

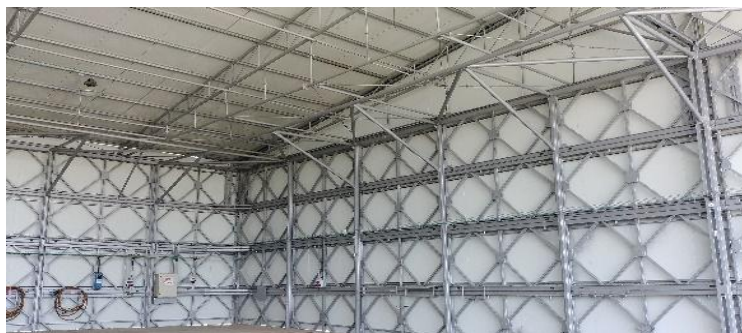
The shed, with a full paint system is in very good condition. No signs of rust spots inside or outside the shed.

shed condition after treatment
